After the Royal Thai Air Force commenced bringing helicopters into service in 1950 with the introduction of the H1 (WS-51) and H2 (Hiller 360), 1953 saw additional helicopters being sought. United States military assistance offered another two types of helicopter with the H2A (UH-12B Raven) and the H1A (YH-5A). However these were small helicopters with a primary purpose of Search and Rescue. If these aircraft were used for other tasks they would find the tasks difficult because of their small size. This led to consideration of a new larger helicopter. This committee consisted of Air Vice Marshall Thawi Culasap, Chief of Staff of the Royal Thai Air Force (rank and appointment at that time) as Chairman. A decision was made to purchase six S-55 aircraft from the Sikorsky Company of the USA. This purchase was made through a Sikorsky intermediary – the Thai Technical Company Limited. The price was US\$152,150 per aircraft. All six aircraft were delivered on 10 July 1954. After all delivery checks were completed, the aircraft was designated Helicopter Type 3 or H3. The aircraft were assigned to Number 1 Platoon, 63 Squadron of Wing 6 at Don Muang. Aircraft numbers were RTAF H3-1/97 to H3

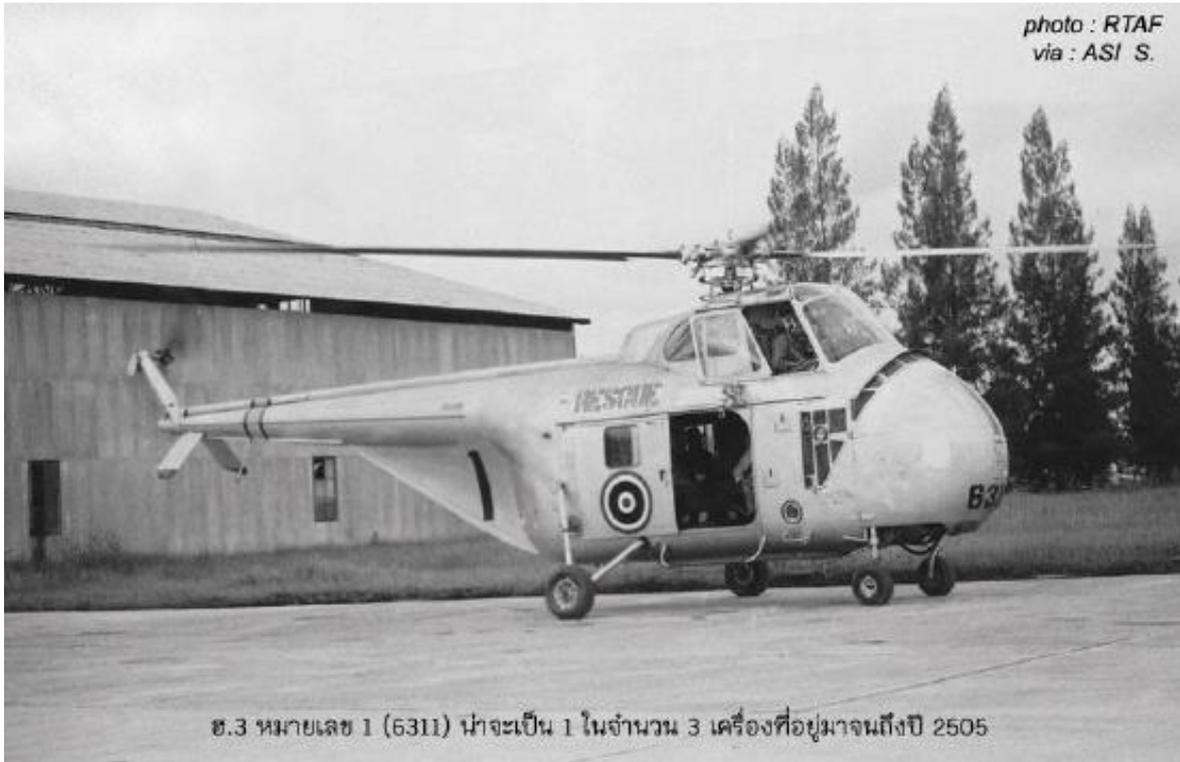
H3 Number 1 (6311) was probably one of the three aircraft still in service till 1962.

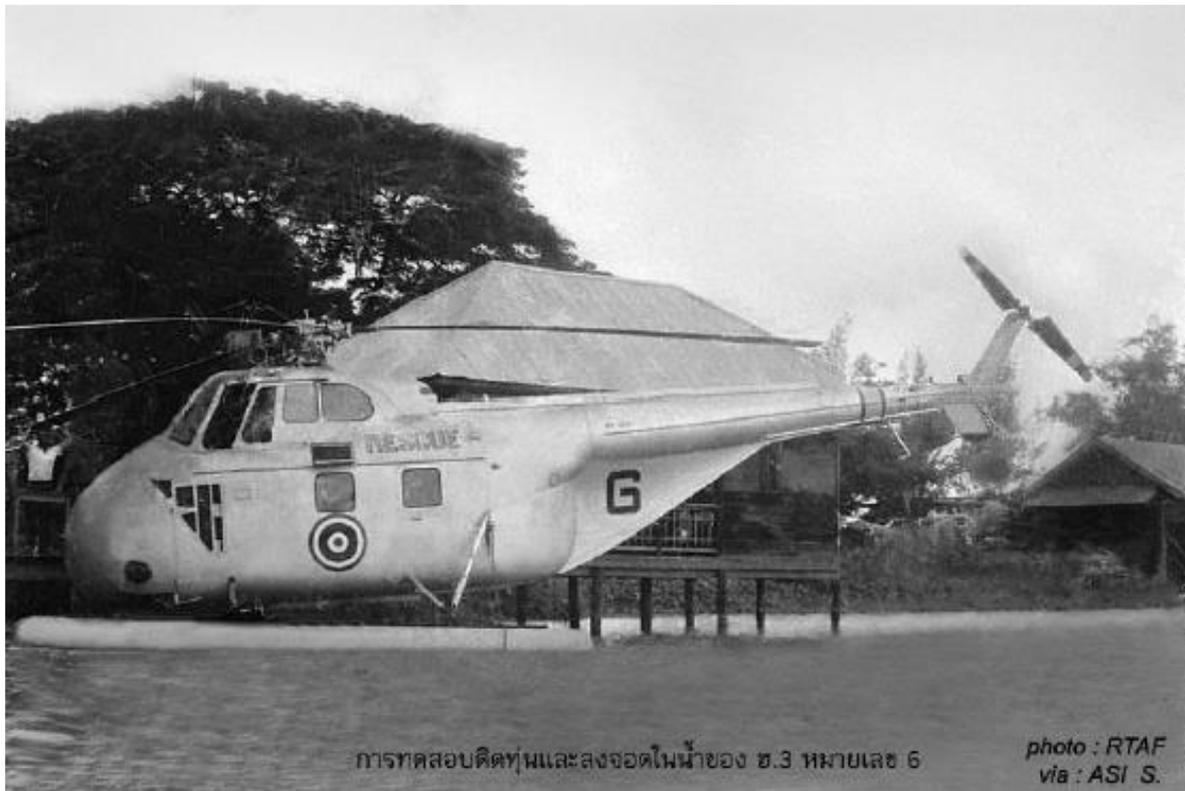
Aircraft Number 6 being tested with floats, after landing on water.

The H3 helicopters of 63 Squadron were used in various missions, regardless of it being administrative flying, general flying; whether it was on a mission for the RTAF itself ie air transport, transporting senior commanders to operations in various far-flung provinces or flying in support of other operations for which the call had gone out. This could include the transport of officials or Committees of the World Court who came to examine evidence in the case between Cambodia and Thailand over the Prasart Khao PhraWihan. The Prime Ministers of Thailand at that time, Field Marshal P. Phibulsonkhram, and Field Marshal Sarit Thanarat used the RTAF H3 helicopters several times to conduct inspections of public service officials. However, the primary role of the H3 aircraft was rescue of those in peril, or the survivors of an aircraft accident. If you look at it, you would see the H3 carried the English word 'RESCUE' on both sides of the fuselage. This is surely clear confirmation of its primary role. With the H3 used in this role, it surpassed the smaller H1A and H2A aircraft because of its larger size and better capabilities in a number of areas. As well, when the aircraft were purchased, some float kits were also acquired. As you can see from the photos of Number 6 or 6316. This allowed the aircraft to conduct operations for crashed aircraft or personnel in areas of water; such as rivers and the sea. These floats were described as 'hot dog' floats because of their shape. However these floats were only used on very few occasions. The first time was a test of their use. This was because it was easy to flip the helicopter when using floats on water. H3 Number 6 was fitted with floats and had several test flights for water take-offs and landings from a large pond near Bangkrabi district of Patumthani Province. This allowed pilots to build their knowledge and experience. As far as we have seen photos of the H3, the furthest that the floats were used was in the search for a Type 15 fighter aircraft (F8F-1/1B Bearcat) which had experienced an accident outside an airfield of Wing 2 Koke Kratiam in 1955. However, after that occasion the floats were taken off and never refitted.

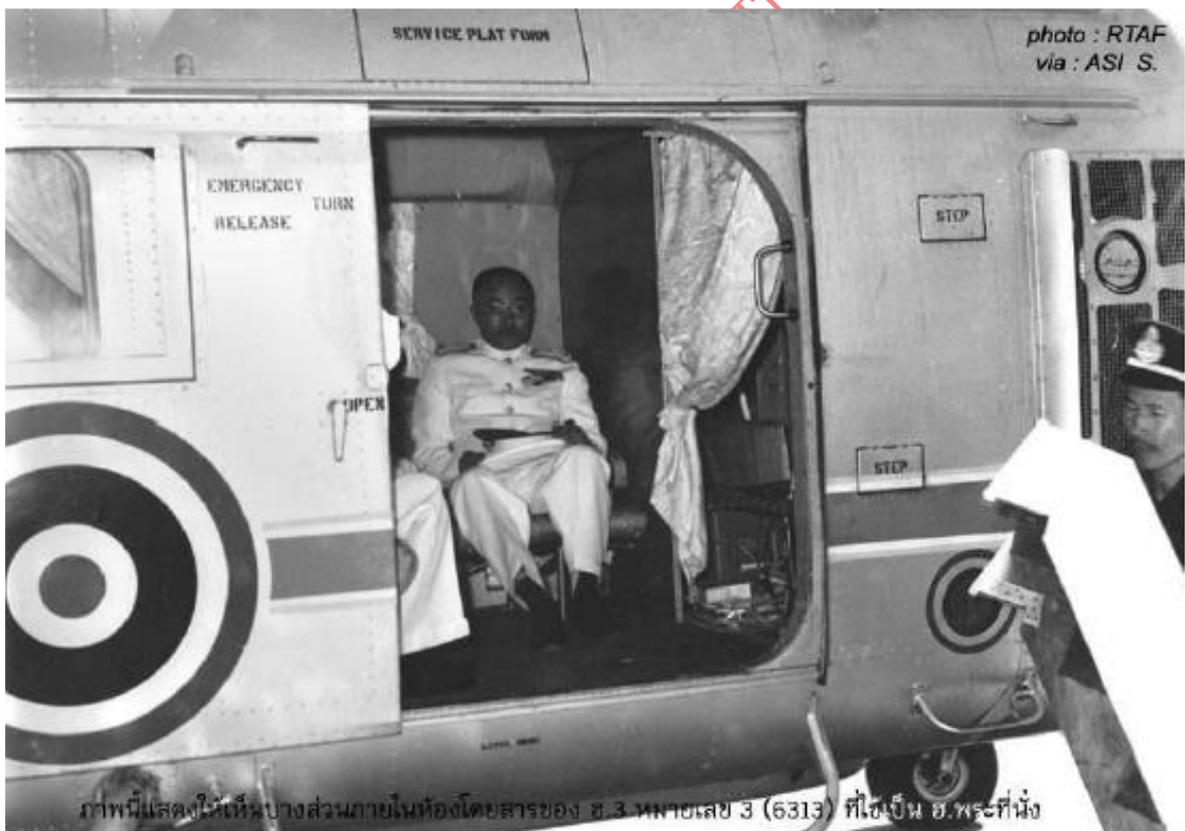
This photo shows some features of the interior of the passenger compartment of aircraft Number 3 (6313) when it was a Royal Transport.

The H3 aircraft Number 4 (6314) which had been designated as Royal Transport had a new interior for its passenger compartment, with new seats and facilities for His Majesty the King and Her Majesty Princess Sirikit the Queen and the Royal officials. However the exterior remained the same as the standard H3 fleet. Later this aircraft suffered an accident in Hot District of Chiang Mai Province on 15 June 1959. There was extensive damage and it was taken out of service. Therefore another H3 aircraft was designated as Royal Transport to replace the damaged aircraft. 63 Squadron designated H3 Number 3 (6313) which had previously been the reserve Royal Transport in the Kradung Mountain operation. Apart from the interior design of the passenger compartment, the exterior colours and markings were changed from the standard H3 fleet. It is believed that H3 Number 3 (6313) was the first RTAF aircraft to carry special colours and markings as a dedicated Royal Transport aircraft.
